Analysis of shipboard fire/explosion accidents occurred in the Turkish search and rescue area

Yılmaz, F. (2021). Analysis of shipboard fire/explosion accident occurred in the Turkish search and rescue area. *Aquatic Research*, 4(3), 214-232.

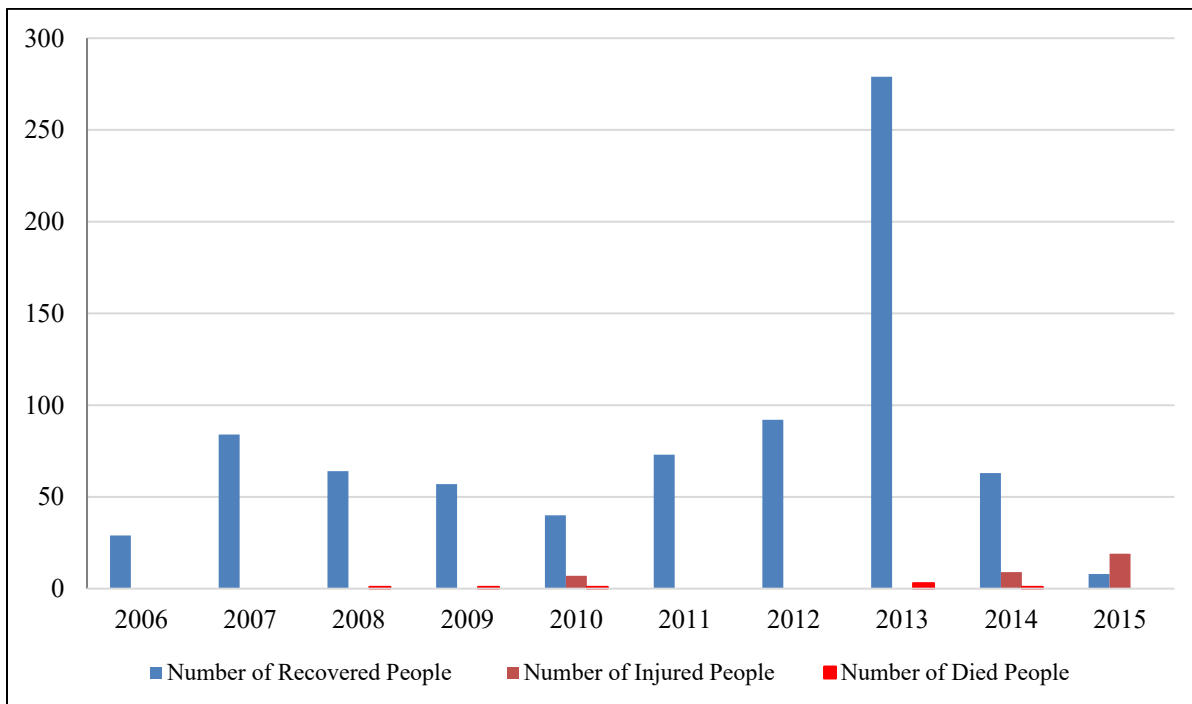
Figure 1. Number of people recovered, injured and died due to shipboard fires/explosions

As seen from the Table 1 and Figure 1, 789 people were recovered, 35 people were injured, and 7 people were died due to 127 fire/explosion casualties occurred on ships in the Turkish SAR area between 2006-2015.

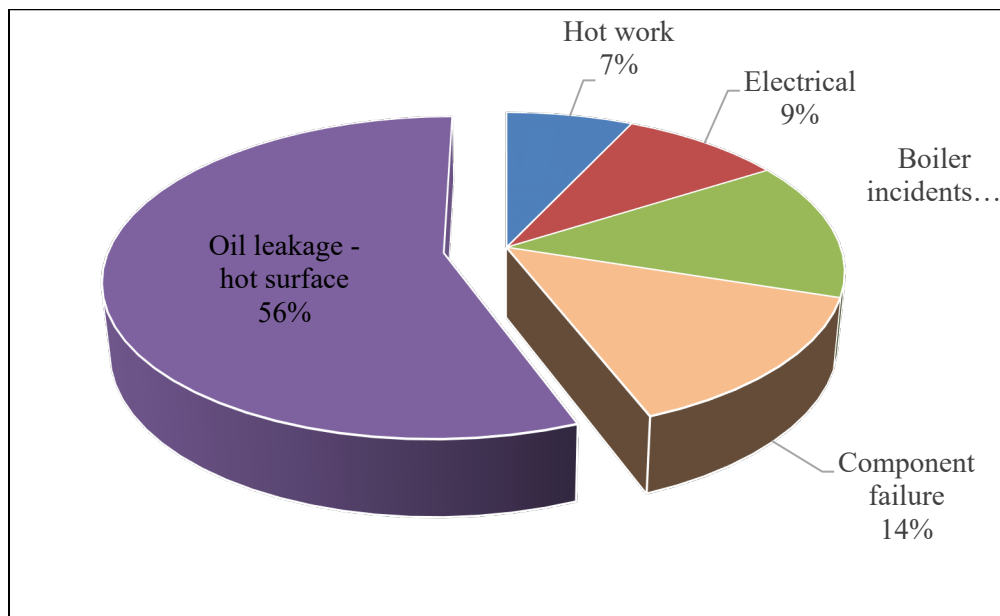
Figure 3. Causes of engine room fires (Krystosik-Gromadzińska, 2016)

According to the statistical analysis carried out in this study, it has been observed that most of shipboard fires/explosions were occurred in the “machinery spaces” of the ships. According to Krystosik-Gromadzińska (2016), 50% of all engine room fires are due to the combination of oil leakage with a hot surface. Figure 3 also shows causes of engine room fires according to Krystosik-Gromadzińska (2016).
