# Strength performance evaluations of vehicle cylindrical lpg tanks

# Strength Performance Evaluations of Vehicle Cylindrical LPG Tanks

*Araştırma Makalesi / Research Article*

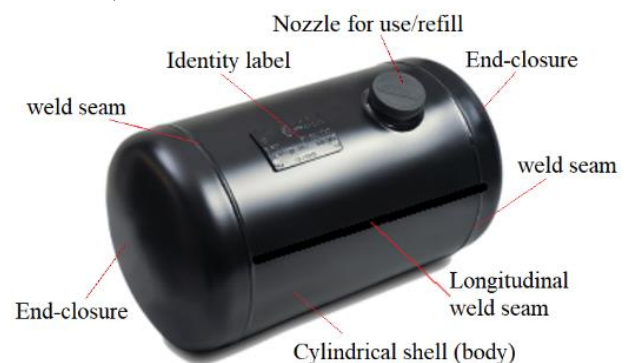
**Figure 1.** Design components of the vehicle cylindrical LPG tank

The nominal dimensions of the cylindrical LPG tanks were generally designed with the volume capacity of 40 l and 60 l including design parameters of inner diameter (ID) of 315 mm, shell thickness (t) of 2.5 mm and different length (L) ranges from 470 mm to 1135 mm. The cylindrical tanks are consisting of five main components; a cylindrical shell (body), two end-closures, a use/refill nozzle and a tank identity label (see Figure 1). They are generally produced from Erdemir 6842 coded (EN 10120) hot rolled steel sheets with a coming thickness of 2~3 mm [32, 33]. All manufacturers are using the Erdemir 6842 (EN 10120) low carbon (0.18% C) alloy steel material to produce the LPG cylindrical tanks to comply with the Regulations. The average sheet thickness of coming sheet was measured as 2.5 mm at cross-sections of the cylindrical shell (body). The cylindrical shell is produced by bending a rectangular sheet and welded at the ends in axial direction (see Figure 1). The cylindrical shell is closed by two end-closures that are produced by deep drawing (or spinning) process [34] using circumferential arc weld seams at both ends. They are also equipped with an inlet nozzle including a two-way hermetic valve to fill and a tank identity label welded to the body as illustrated in Figure 1. All tanks are subjected to heat treatment process to relieve the residual stresses after all manufacturing processes are finished.

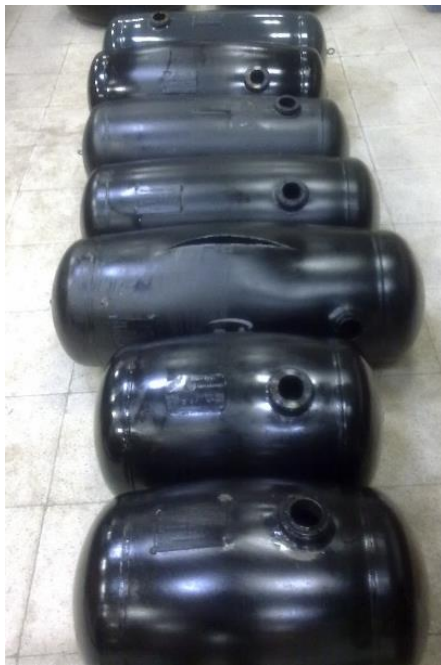
Figure 3. (a) Burst tank specimens

In this study, 10 LPG tanks from each manufacturer's products (5 tanks each for 40 l and 60 l, totally 60 samples) were used for the burst tests only. The specimens were initially loaded by quasi-static internal pressure until they collapsed and subsequently internally pressurized until burst. Figure 3.b shows tanks with a volume of 40 l and 60 l, which were burst by volumetric

expansion (like a barrel) at the end of the experimental study.

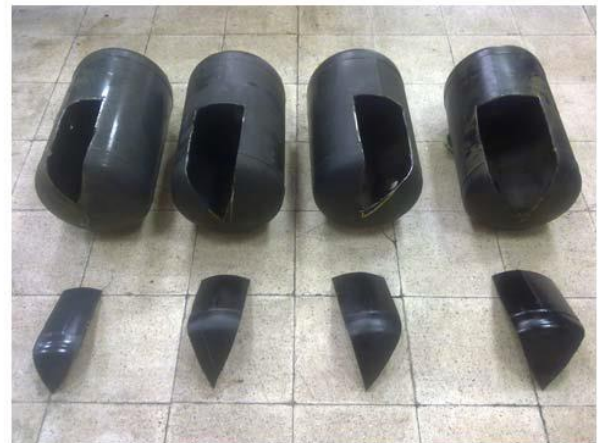
**Figure 8.** (a) Cross-section of the cylindrical tanks

In order to measure the wall thickness of the cylindrical tanks exactly, the cylindrical shell body was cut out to represent the torispherical cap and the knuckle zone (1/16 of the whole tank), as shown in Figure 8.a. These sections were measured accurately point from “a” to “s” with a micrometer to consider in the simulations (Figure 8.b).
